Manhole Inspection Summary

Manhole # S09CC2027MH

Insp Date: **10/25/06 2:14 PM**

Location Address: **5900 GREENSPRING AVE**

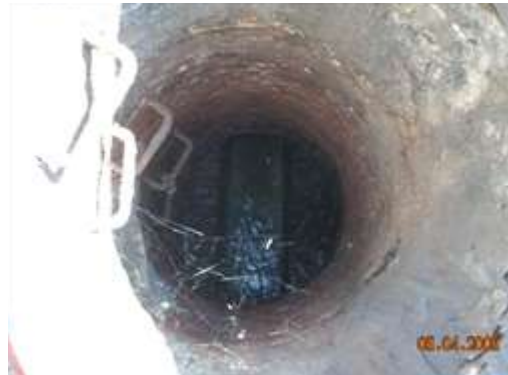
Top View

Corroded steps. Evidence of surcharge - Bench debris.

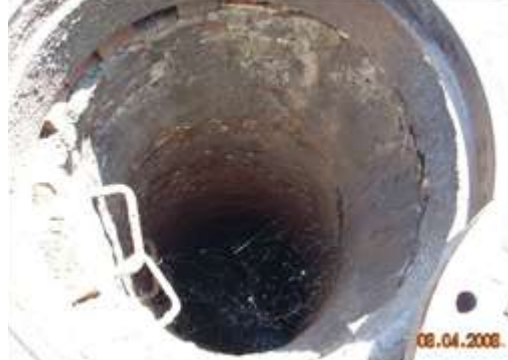
Defect

Frame leaks. Adjustment deterioration, loose brick and infiltration. Barrel infiltration.

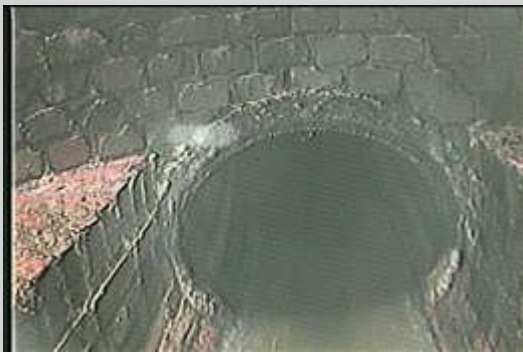
Pipe Out @ 12 O'Clock

Infiltration: **Evidence** Pipe Seal Cond: **Cracked**

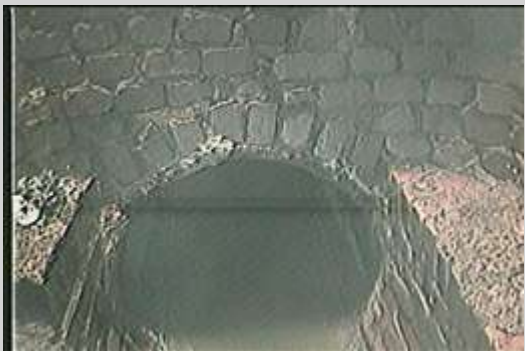
24 in. Circular Gravity Sewer
Pipe In @ 6 O'Clock

Barrel deterioration and infiltration.

Infiltration: **Evidence** Pipe Seal Cond: **Broken**
